Name of Client:	Jane & John Doe		
Address:	1234 Any-Town South Florida		
ID#:	XXXX-XXX-XXXX-XX		
Date:	xx-xx-xxx		
Type of Inspection:	Full, 4-Point, & Wind Mitigation Inspections		
Cost:	\$XXX.00		
Start Time:	10:00 am	End Time:	11:30 am
Weather:	Warm & Sunny

Type of Structure:	Detached Single Family	Year:	1935	Occupied:	Yes*
Foundation Type	CrawlspacE	Structure Type	Concrete Block	# of Floors	1
Square Footage:	1,403	# of Beds:	3	# of Baths:	2

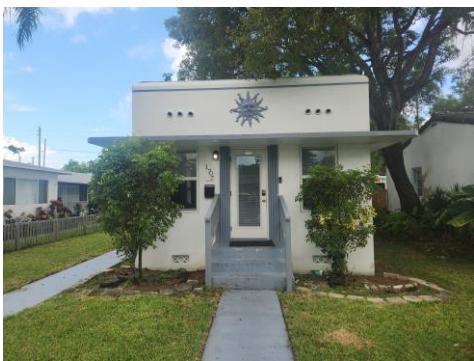
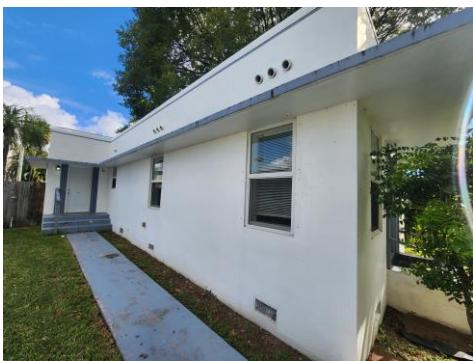
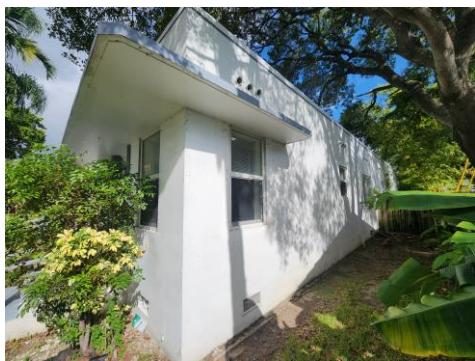
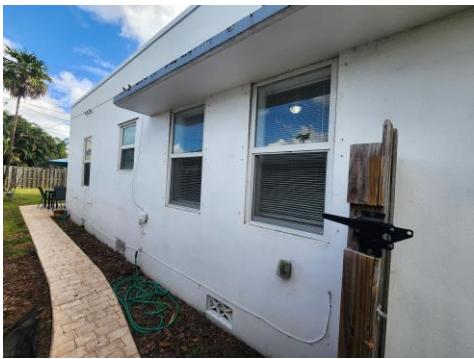
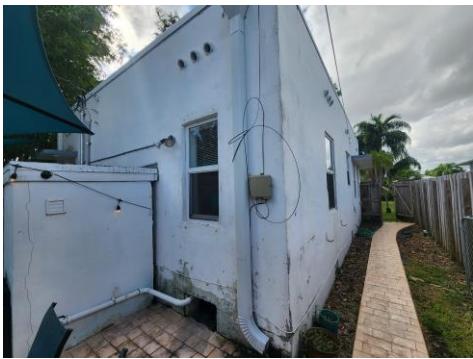
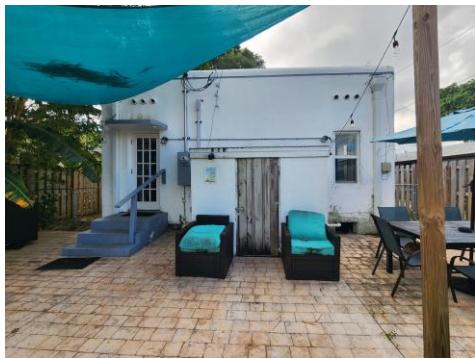
Exterior Wall Covering	Stucco	Exterior Wall Condition	Satisfactory
Walkway Material	Concrete	Walkway Condition	Satisfactory
Exterior Door Material	Tempered Glass	Exterior Door Condition	Satisfactory
Window Material	Laminated Glass	Window Condition	Satisfactory
General Slope	Level	Other Structure/s	Wood Fence & Shed
Crawlspace	<u>Unsatisfactory</u>

- The crawlspace is filled with debris which makes it hazardous to traverse, clearing out the debris to make it safely accessible to contractors for future maintenance/inspection is suggested.
- Two of the crawlspace entrances are not secure, sealing all entrances tightly to avoid small animal habitation is suggested.
- It appears some of the crawlspace joists have been replaced, however it also appears that a small section near or under the master bath is damaged or rotted, but could not be accessed due to the debris, further evaluation and possible repair is suggested.
- Settlement cracks on concrete enclosure of laundry shed do not appear hazardous.

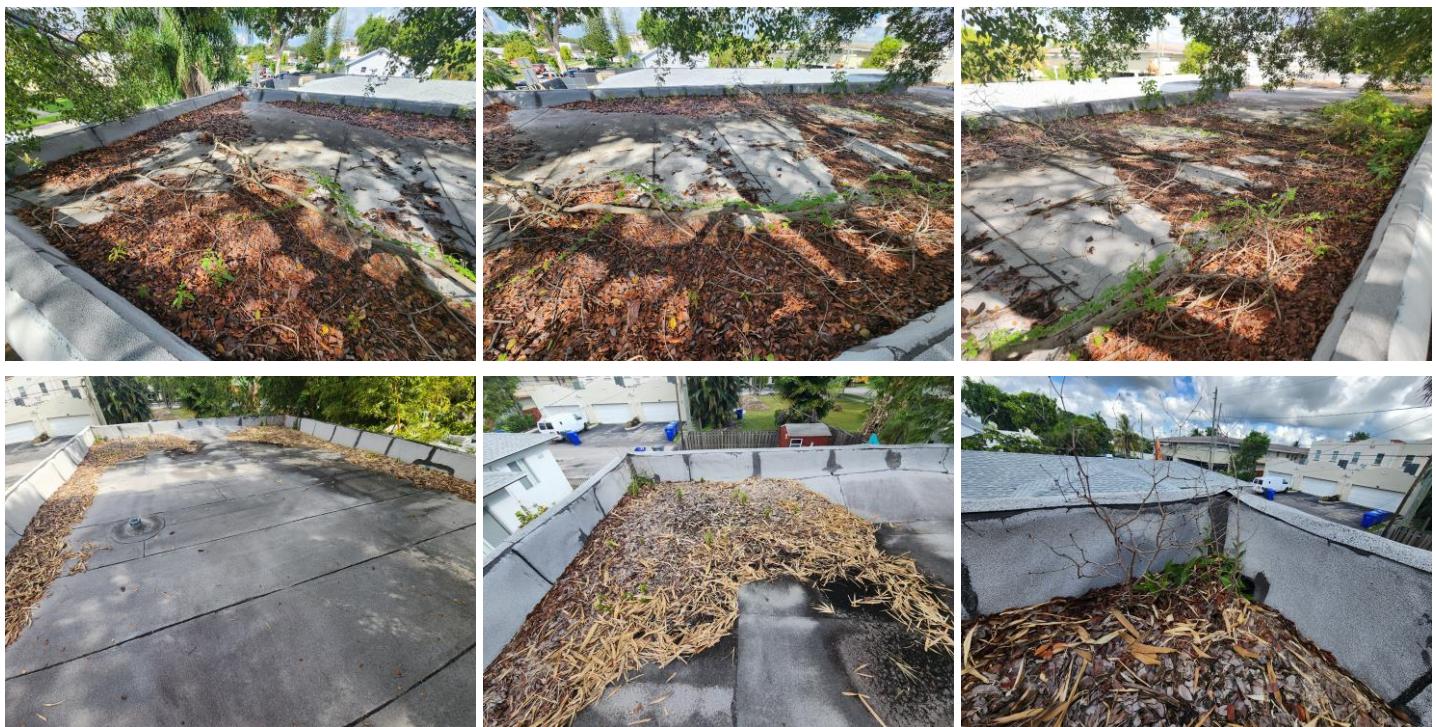
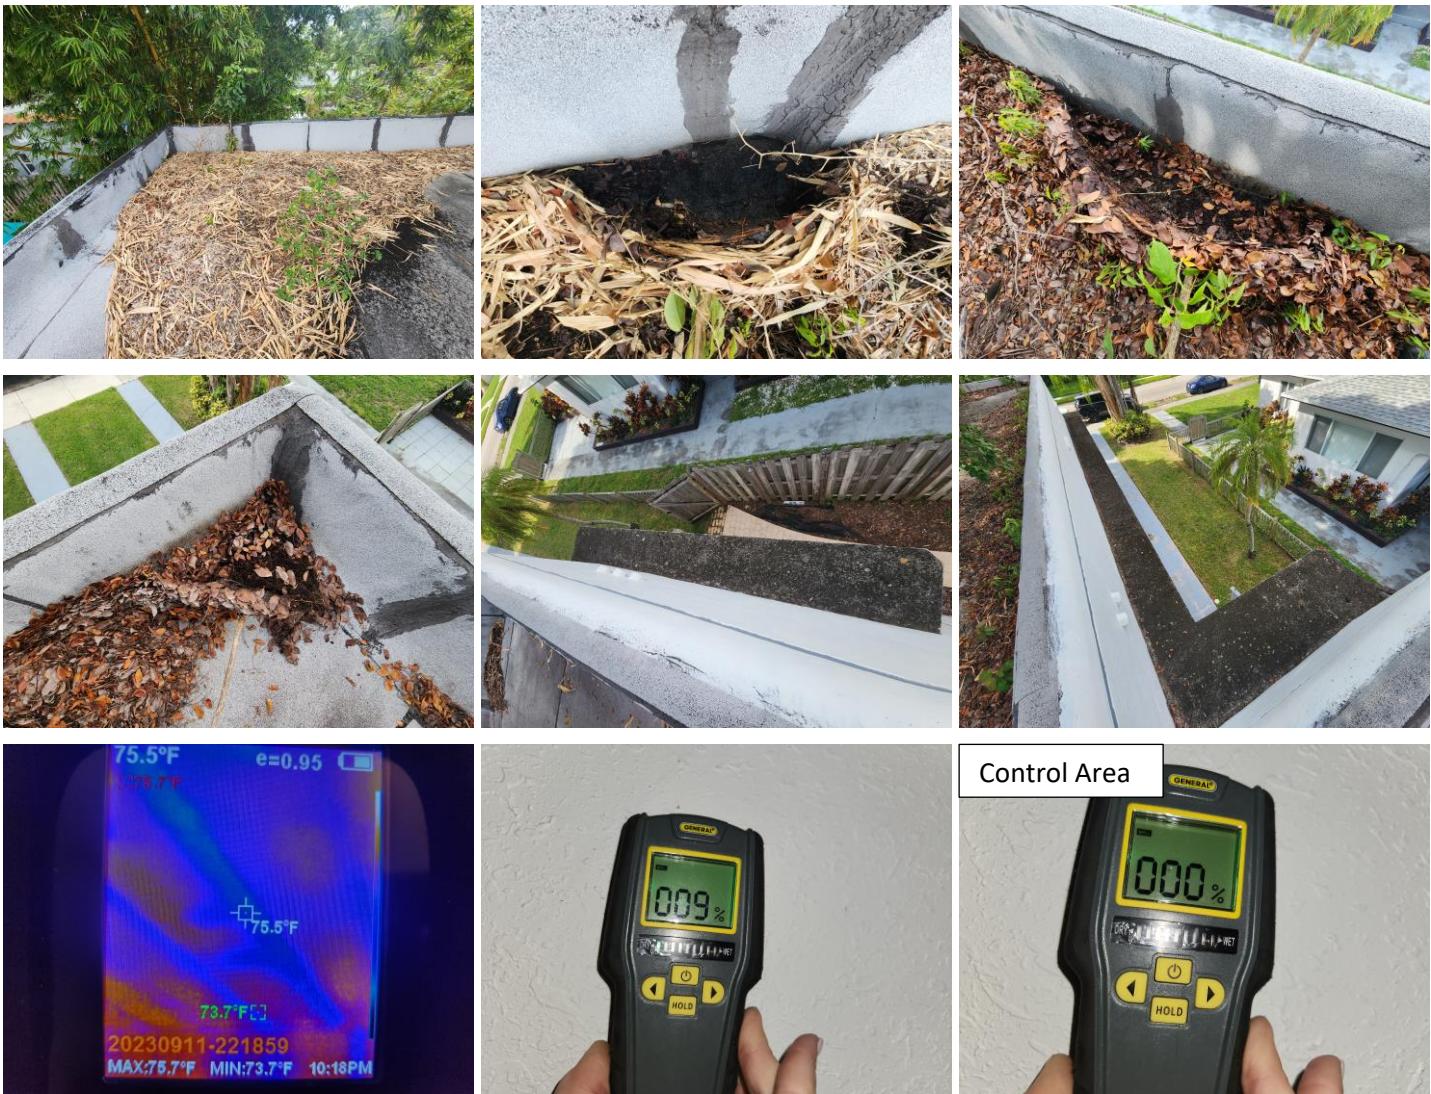
Roof Covering	Modified Bitumen	Roof Covering Condition	<u>Unsatisfactory</u>
Roof Shape	Flat	Condition of Exposed Flashing	Satisfactory
Estimated Remaining Useful Life	End of Life	Date of last Permit Application	<u>03-19-1998</u>

- A current roof permit is not on file for this home, this roof was re-installed without a permit, this may affect insurance coverage eligibility. This roof appears to be +/- 10 years old but cannot be confirmed.
- The neighbor's tree branches are depositing leaves and branches onto the roof top, which are blocking the gutters, and creating soil inches-thick where new trees are beginning to grow. This excessive moisture can drastically reduce the expected useful life of a roof.
- The excessive moisture created by all the debris on the roof may have penetrated through the surface causing higher levels of moisture on the master bedroom ceiling, this indicates a leak, a new roof is suggested.

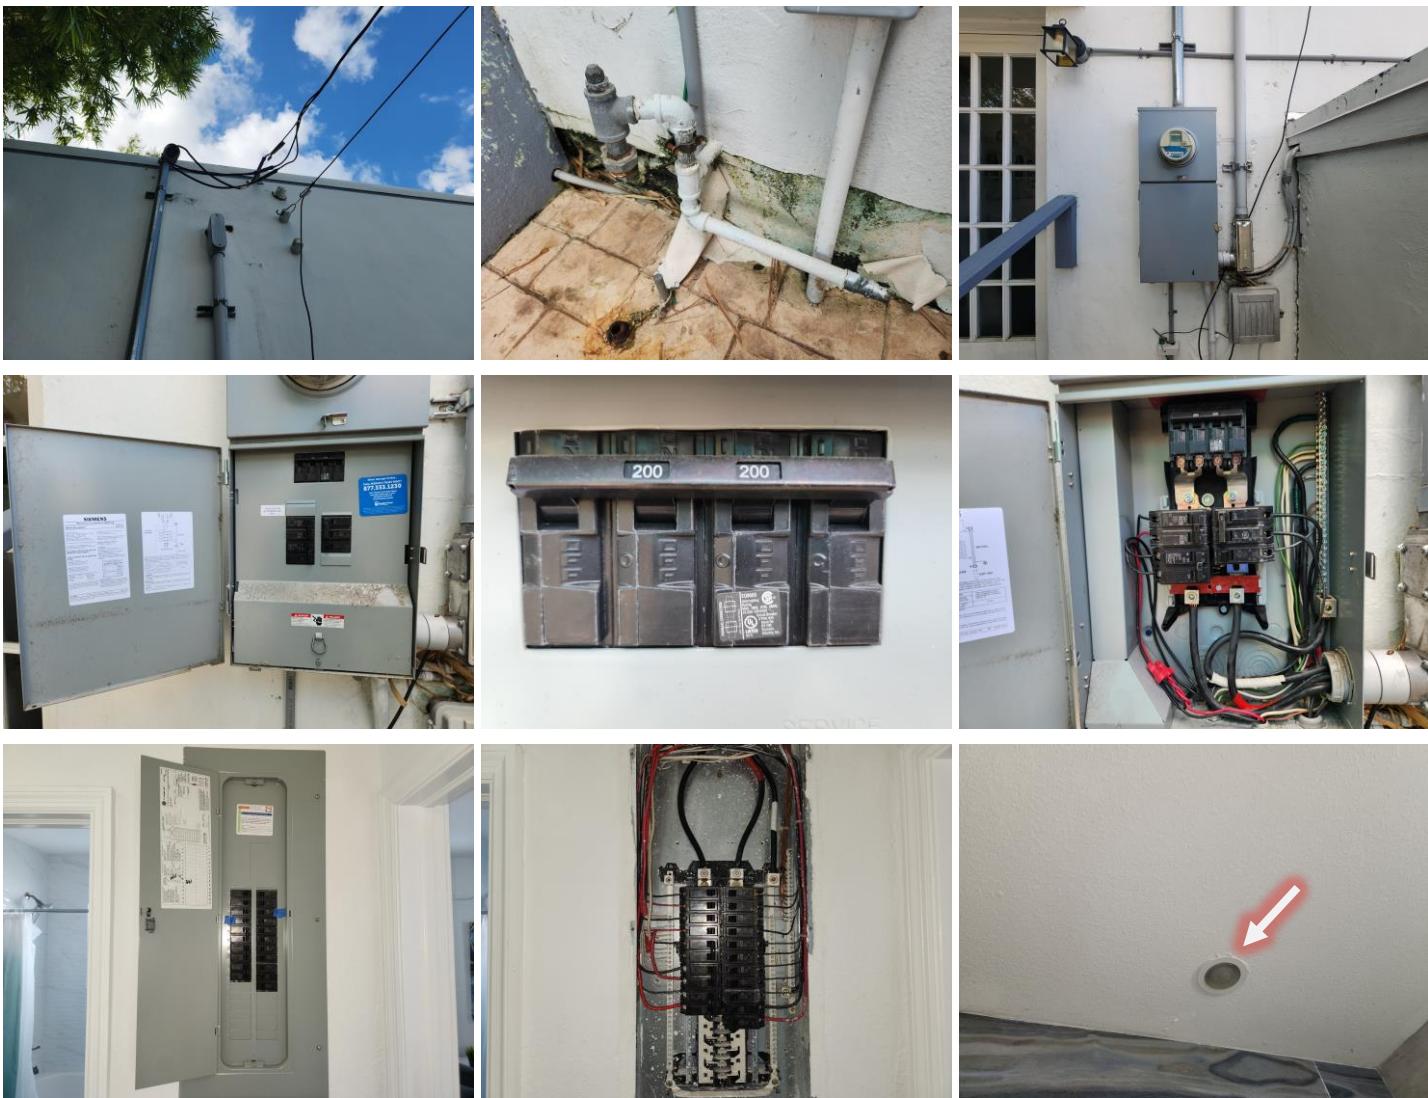
Type of Service	Overhead	Type of System Ground	<u>Rod & Pipe Clamp</u>
Location of Main Panel	Exterior Rear Façade	Service Wire Material	Stranded Copper
Brand of Panel	Siemens	Branch Wire Material	Copper
Location of Distribution Panel	Hall	Service Wire Material	Stranded Copper
Brand of Panel	Siemens	Branch Wire Material	Copper
Estimated Panel Amperage	200	Overload Protection Type	Circuit Breaker
Estimated Panel Age	<u>+/- 5 years</u>	Panel Condition	Satisfactory
Fixture Condition	<u>Marginal</u>	Outlet Condition	Satisfactory

- The system ground consists of 1 rod and a pipe clamp, current standards suggest 2 grounding rods, installation of a second rod is suggested.
- There are no current permits on file for the new electrical panels.
- The light above the master shower was not illuminating at time of inspection, possible burnt-out bulb, or wiring issue, further evaluation is required.

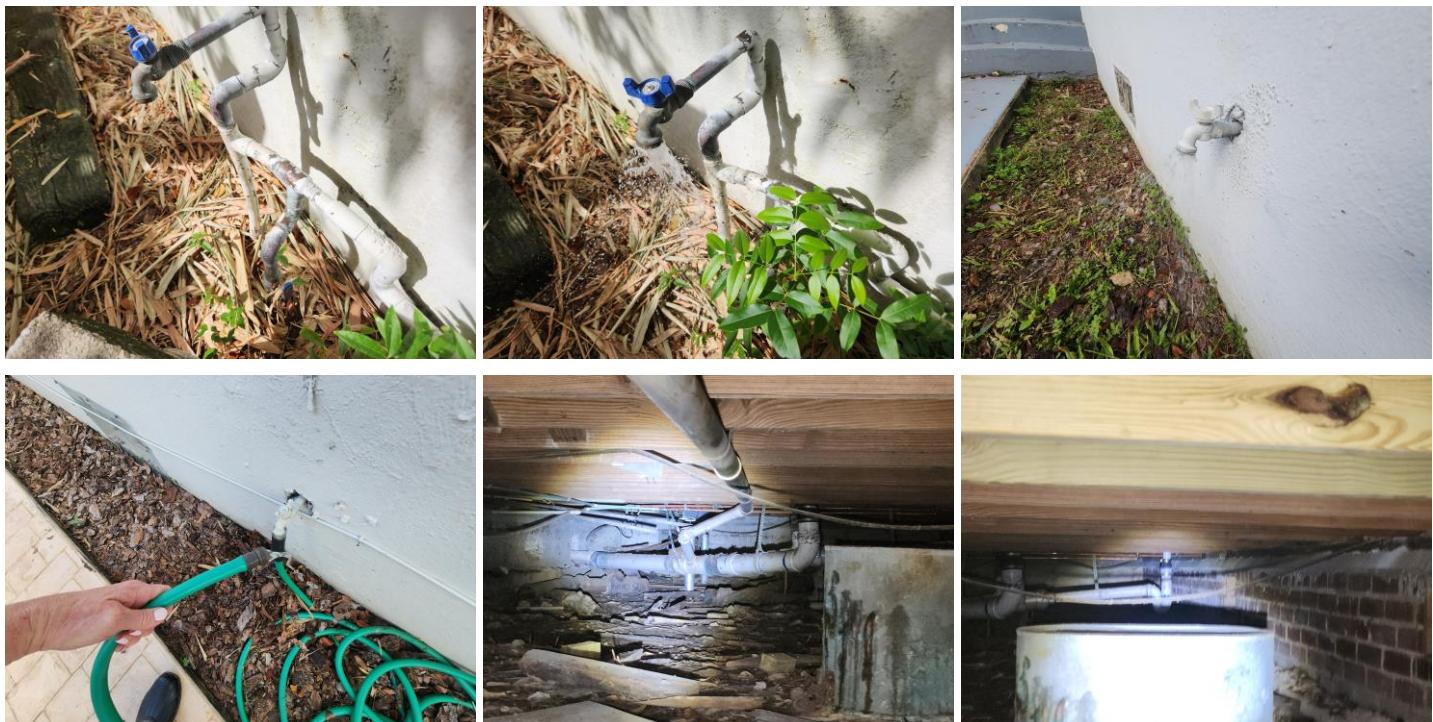
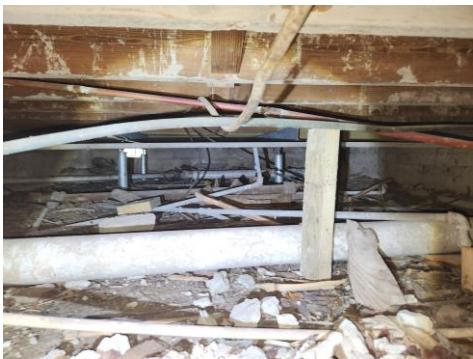
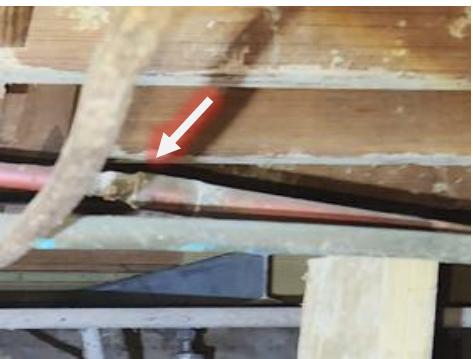
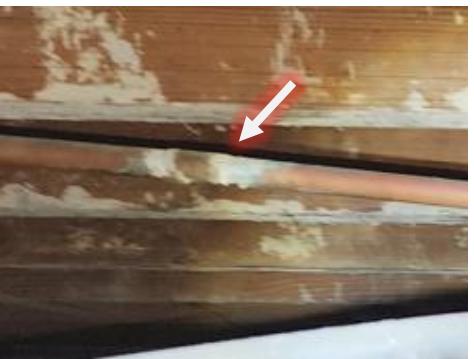
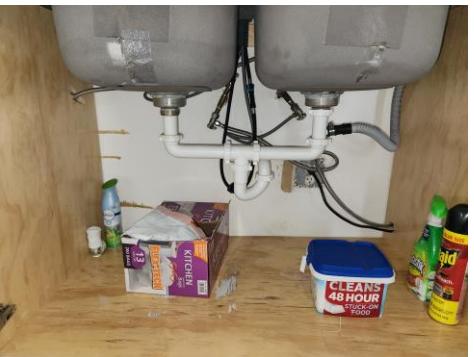
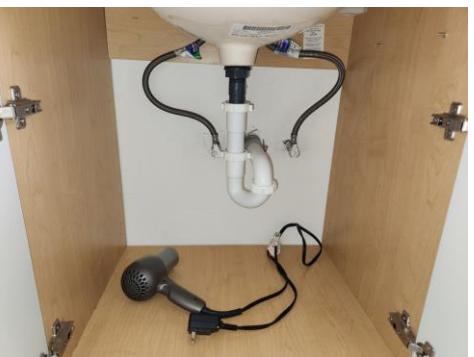
Water Service Type	Municipal	Sewer Service Type	<u>Municipal</u>
Location of Main Valve	Exterior East Façade	Hose Bib Condition	Satisfactory
Condition of Visible Supply Pipes	<u>Marginal</u>	Condition of Visible Waste Pipes	<u>Unsatisfactory</u>
Visible Pipe Materials	Copper, PVC, & <u>Unknown Metal</u>	Valve Condition	Satisfactory

- Home is on public sewer, but given the age of the home an abandoned septic tank may be on site.
- While most of the waste pipes have been updated to PVC under the house, the shared bath sink's waste line appears to be a metal, possibly galvanized metal as it is grey, and the threads have rust.
- There is a section of red copper pipes under the east façade of the home (under kitchen) which appear to have corroded joints.
- The soft floor of the master shower may be due to a shower pan or waste line connection leak (see bathroom section), this may affect insurance coverage eligibility.

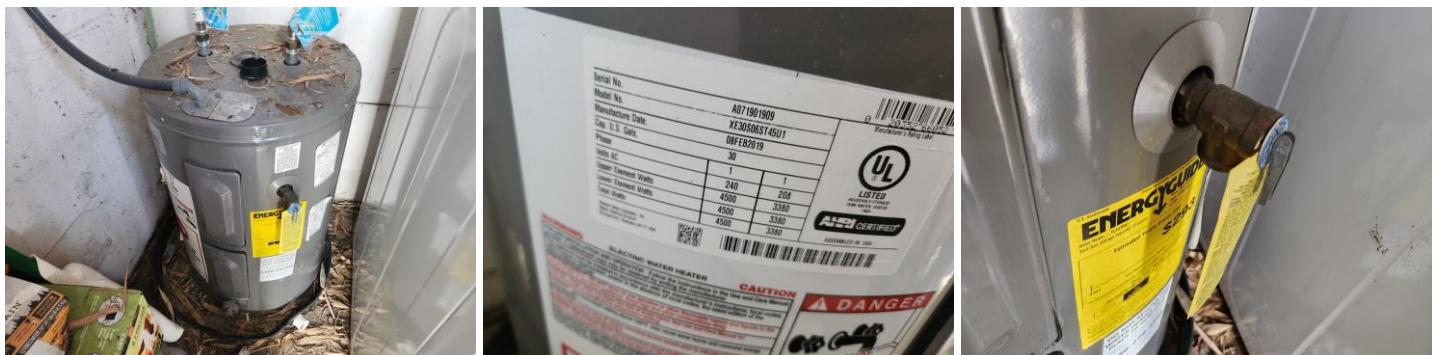
Brand of Water Heater	Rheem	Manufacture Date	2019*
Energy Source	Electric	Temperature Tested	<u>105.6°F</u>
Water Heater Condition	Satisfactory	Location	Laundry Shed
Temperature/Pressure Relief Valve	Present	Capacity	30 Gallons

- The water heater temperature is lower than the standard 115°F, however the thermostats can be raised to meet personal comfort levels.

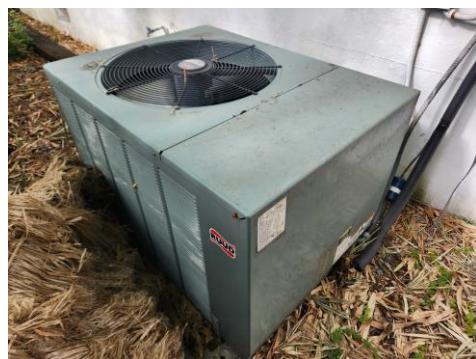
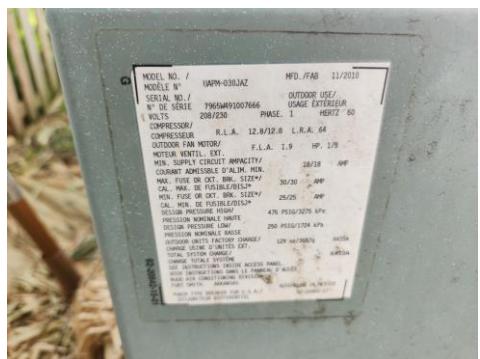
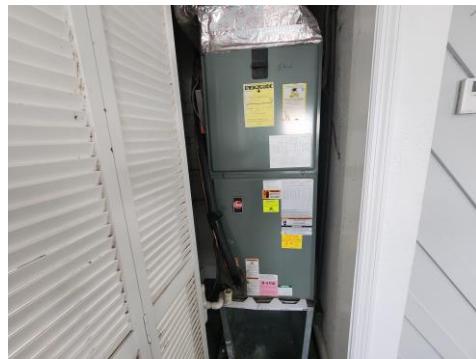
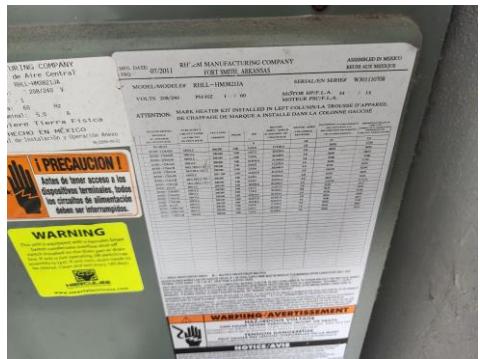
Brand of Air Conditioner Condenser	Ruud	Manufacture Date	2010*
Brand of Air Conditioner Handler	Ruud	Manufacture Date	2011*
Cooling Function	Satisfactory – 55.9°F	Heating Function	Satisfactory – 80.1°F

- There is cold air blowing out of the crawlspace access closest to the A/C condenser, there may be a leak, further evaluation and repair is suggested.
- The air filter is very dirty, replacement is suggested; the cooling fins are clean.

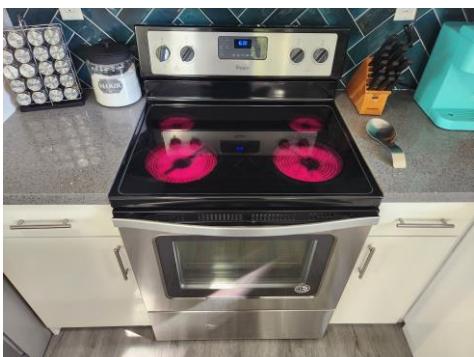
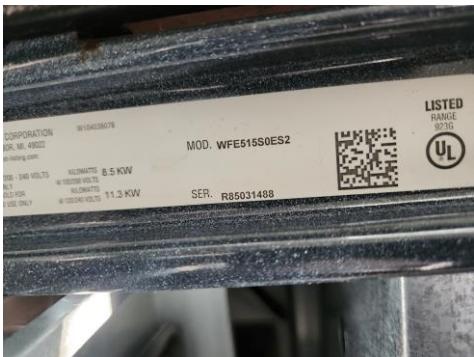
OVEN/RANGE: A section of the LED display screen is not illuminating, and the temperature is running hotter than the set 350°F, the thermostat sensor may need to be repaired.

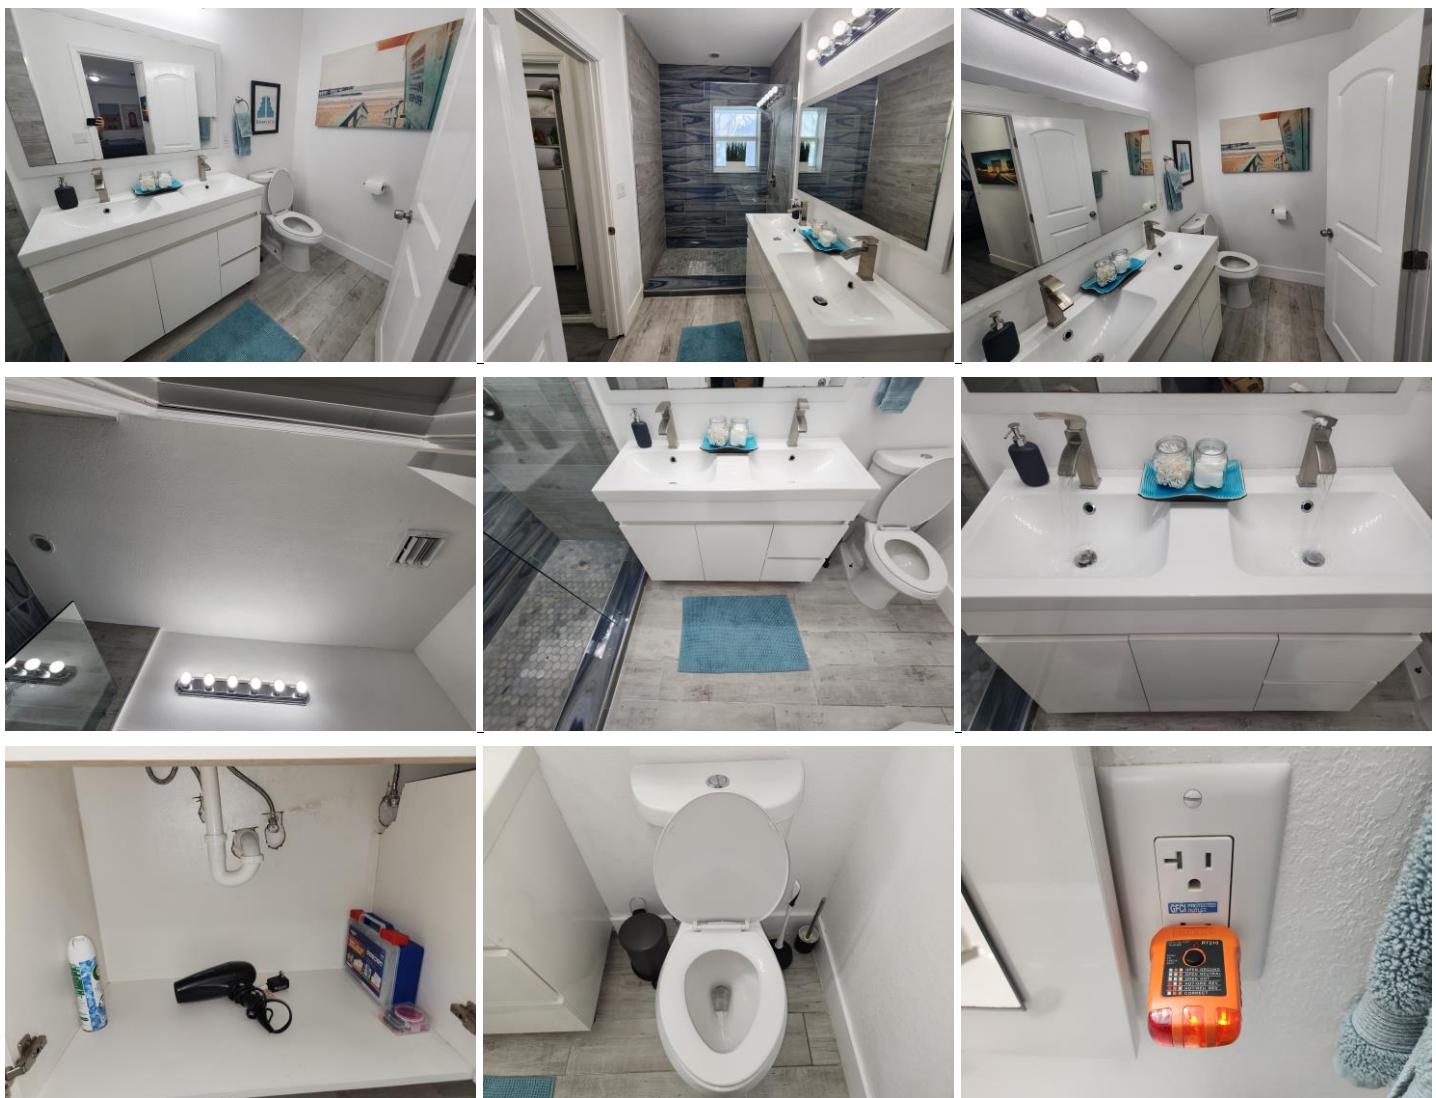
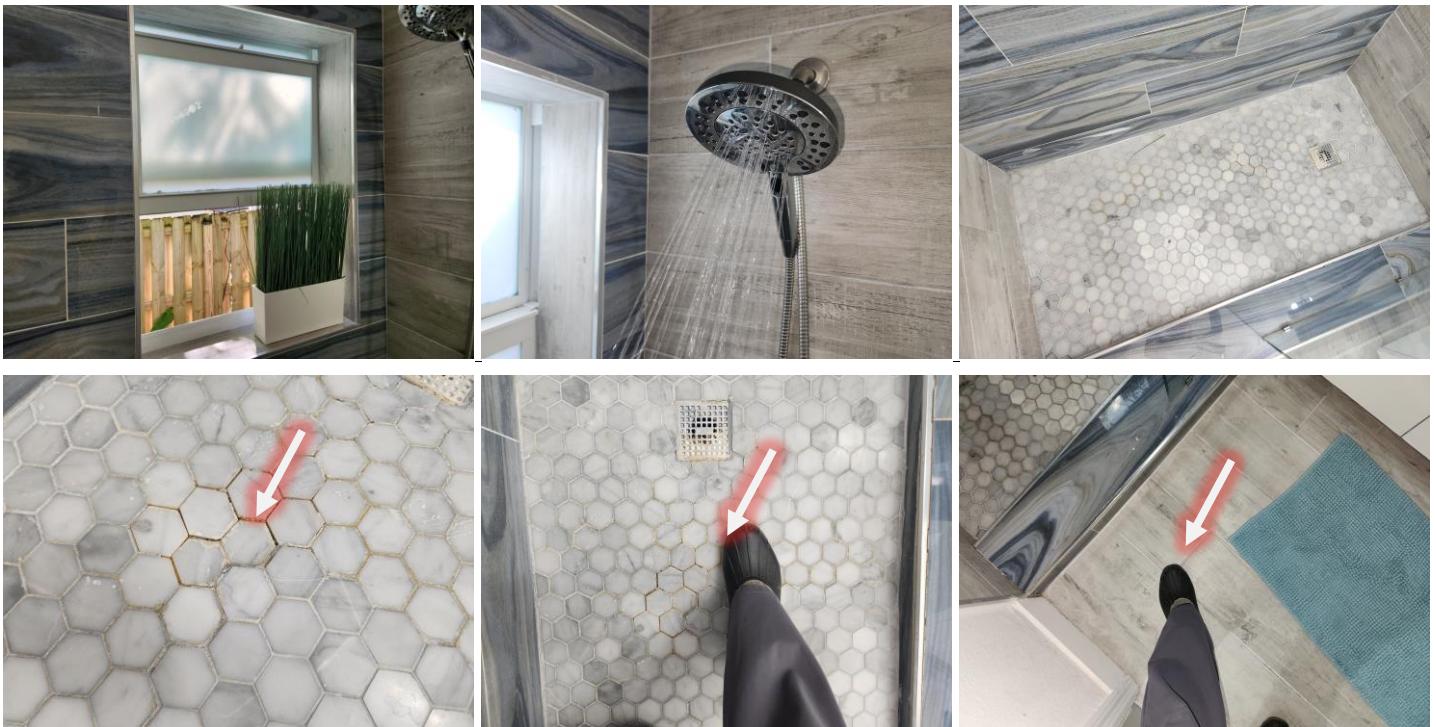
Countertop	Satisfactory	Cabinet Condition	Satisfactory
Flooring	Unsatisfactory	Ceiling	Satisfactory
Toilet	Satisfactory	Tub/Shower Stall	Unsatisfactory
Bidet	N/A	Tub Faucet/Shower Head	Satisfactory
Sink	Satisfactory	Shower Door	Satisfactory
Sink Faucet	Satisfactory	Ventilation Present	Yes
Mirror	Satisfactory	Outlet Available	Yes GFCI Yes

- There is a soft and indented spot on the shower floor and a soft spot on the tile outside the shower, the subfloor may be compromised. Removing the shower floor to repair the subfloor and any other damaged beams or supports is suggested.

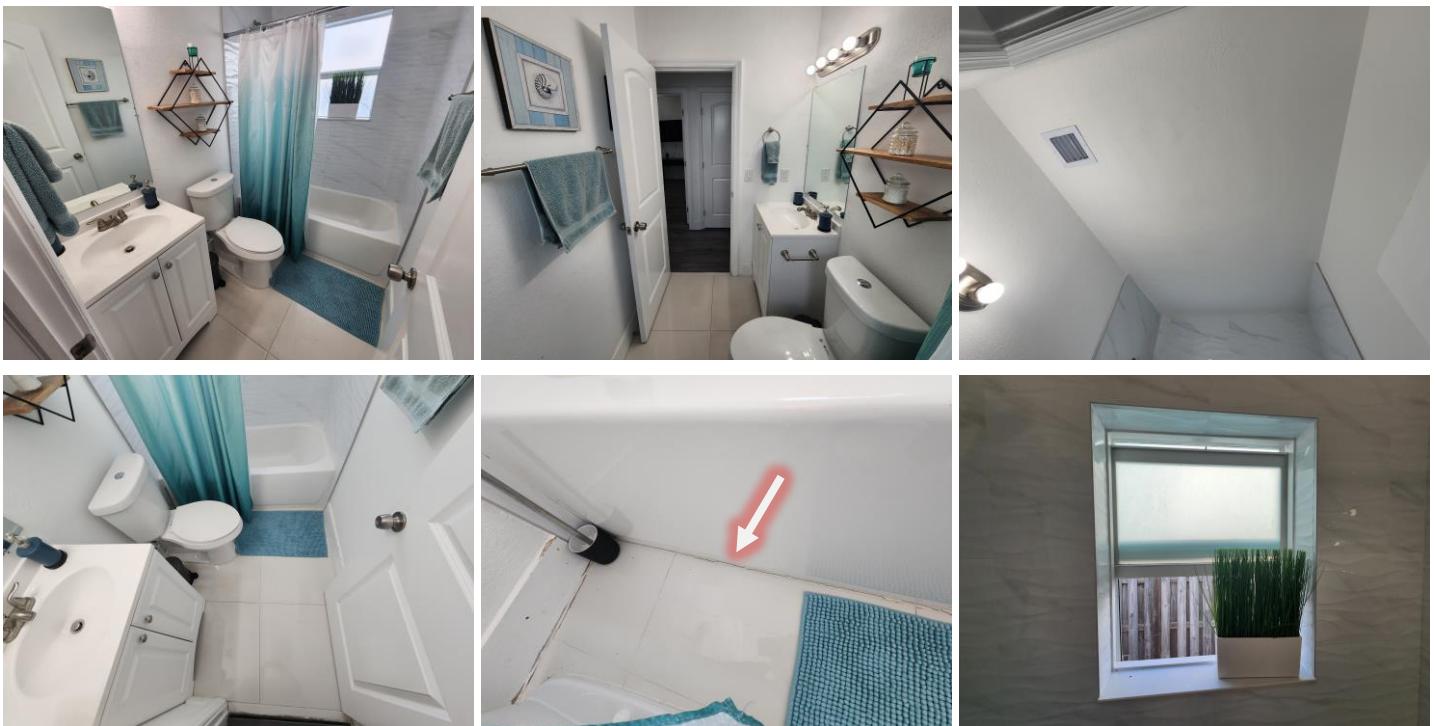
Bath #2 (Shared)

- The caulking between the tub and floor is cracked, this appears to be normal shrinkage/settlement.

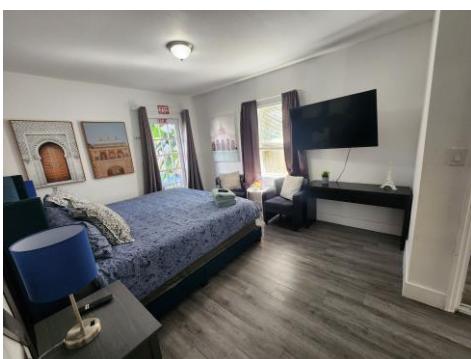
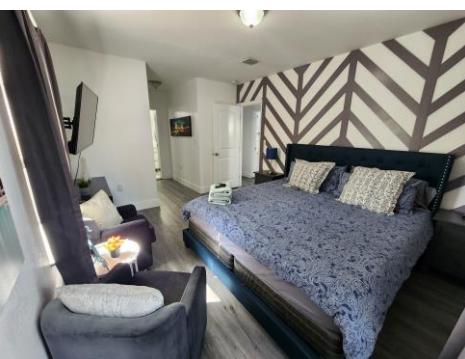
- The ceiling does not have any visible damage, but thermal imaging and a moisture meter show an area of higher moisture levels compared to the nearby control area. This may be coming from seepage of water from the high concentration of the wet, decomposed material on the roof top.

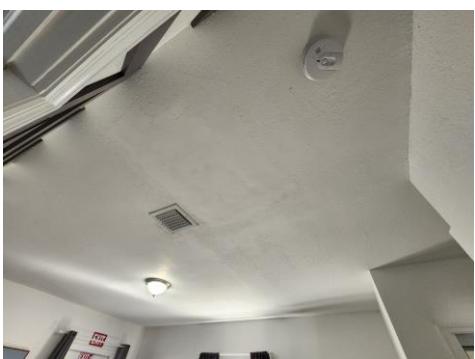
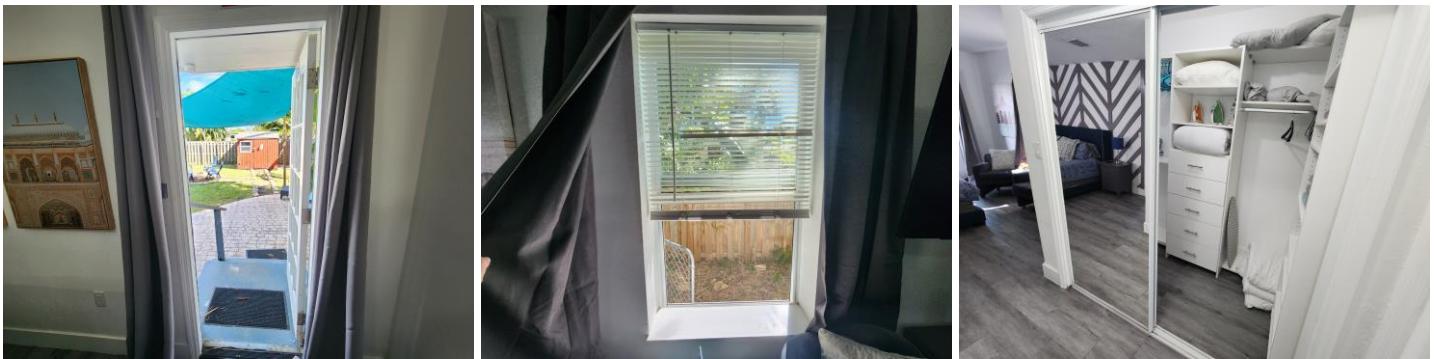
Flooring	Satisfactory	Ceiling	<u>Marginal</u>
Walls	Satisfactory	Smoke Alarm Present	Yes
Window/s	Satisfactory	Fire Egress	Rear Door

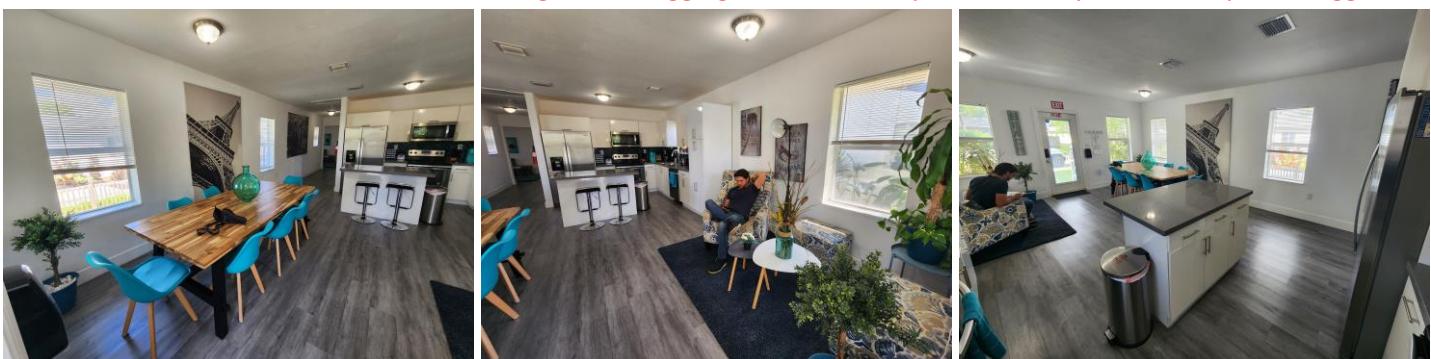
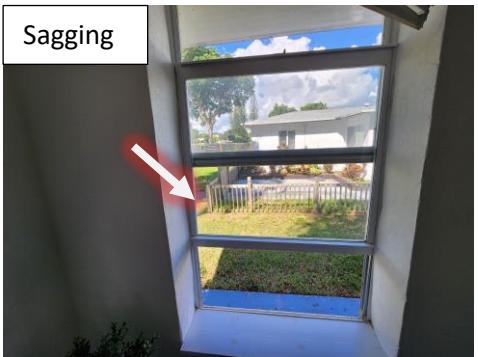
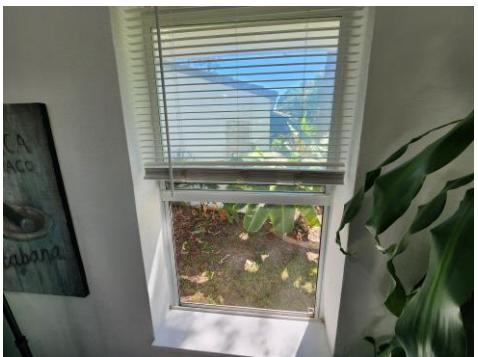
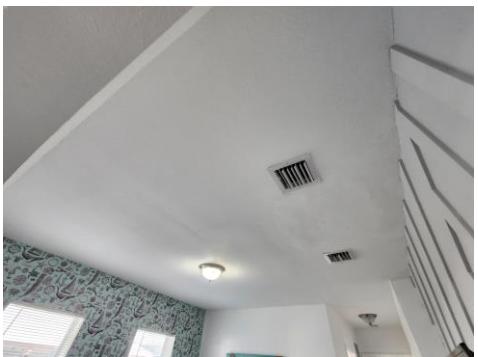
Flooring	<u>Marginal</u>	Ceiling	Satisfactory
Walls	Satisfactory	Smoke Alarm Present	Yes
Window/s	<u>Marginal</u>

- The laminate floor is in good condition but there are some soft areas, it could not be determined if this is due to the subflooring or simply an uneven surface causing the laminate to bow in some areas.
- One of the windows in the main living area is sagging, and one is very difficult to open, track repair is suggested.

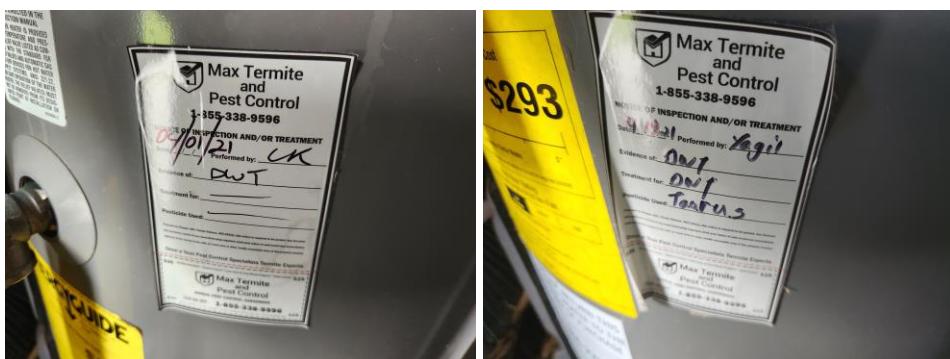
Visible Evidence of Wood Destroying Insects	<u>Yes</u>	Visible Evidence of Wood Destroying Fungus/Rot/Mold	No
Form of Evidence	<u>2021 Treatment Sticker</u>	Form of Evidence	N/A
Location of Evidence	<u>Water Heater</u>	Location	N/A

- Treatment sticker for dry wood termites present, no evidence of live insects, i.e. wings or fecal pellets were witnessed.

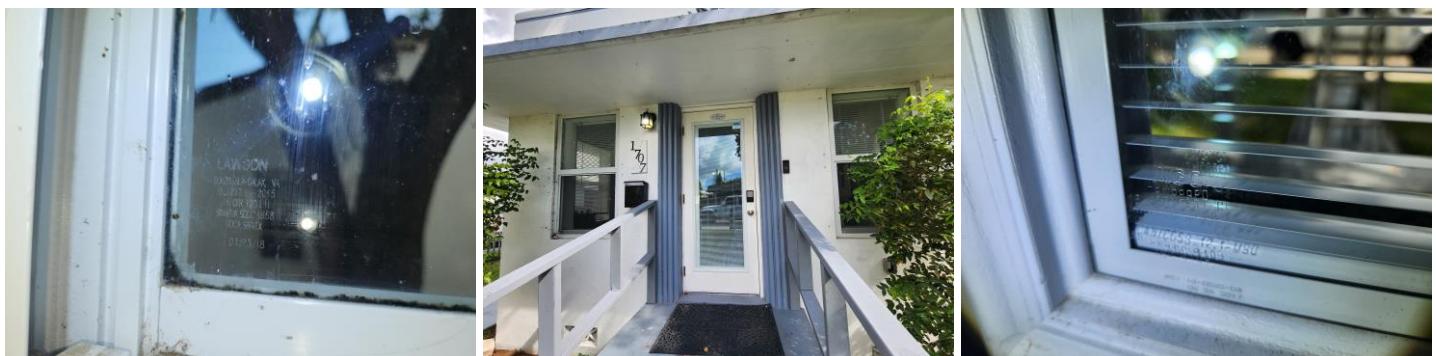
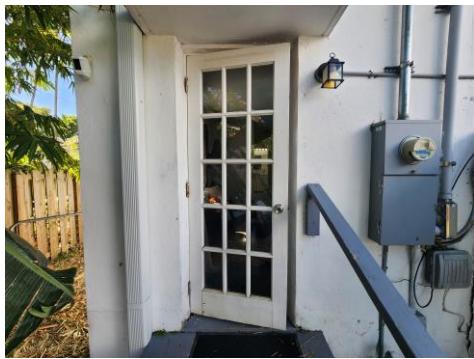
Are All Openings MDCA Protected? No, all windows are Lawson impact, but the front and rear door are not impact rated or have shutter protected.
